Quarterly Progress Report for the Locomotive Fueling Station  
ArcelorMittal Burns Harbor, LLC, IND003913423

**Re: Quarterly Progress Report  
May 2010 through July 2010  
Diesel Fuel Free Product Recovery  
Locomotive and Mobile Equipment Shop**

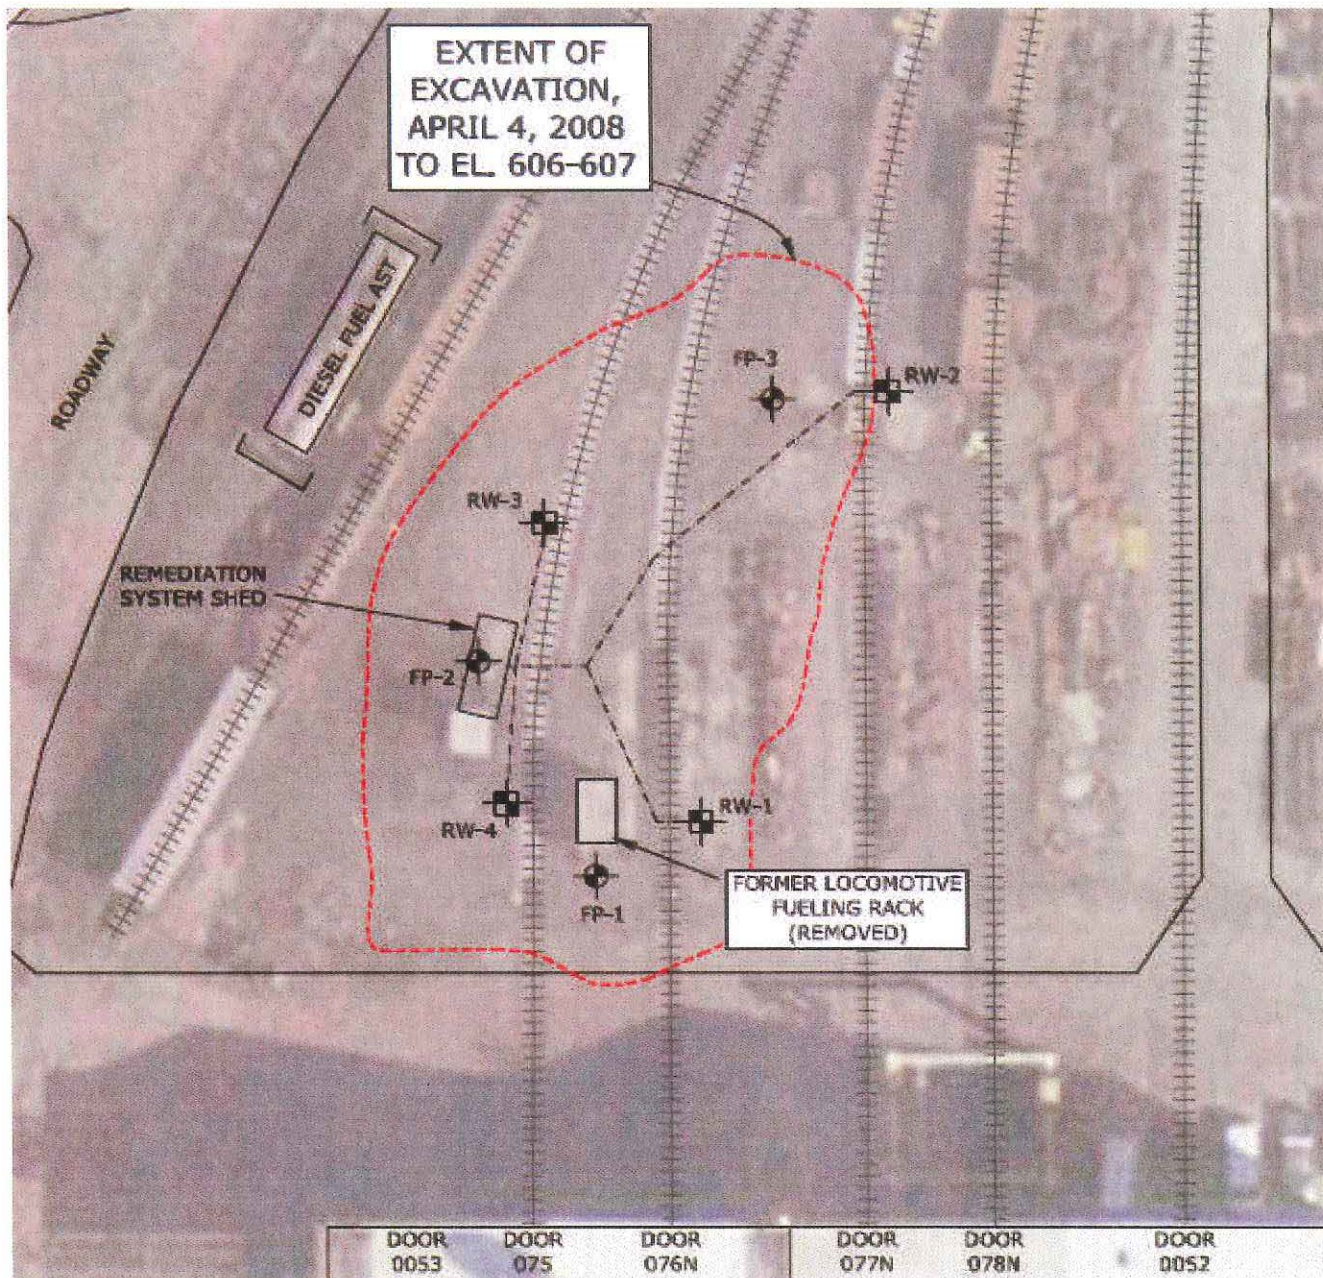
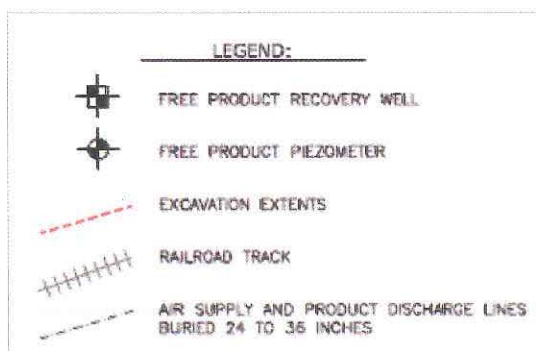
**FIGURE 1**

The remediation system was completed, deployed, and placed into service on March 18, 2009 as illustrated on **Figure 1**. Detailed descriptions of the design, construction, and field configuration of the remediation system are provided in our first quarterly progress report dated August 4, 2009 and omitted herein for brevity. This report succinctly summarizes the continuing operation of the

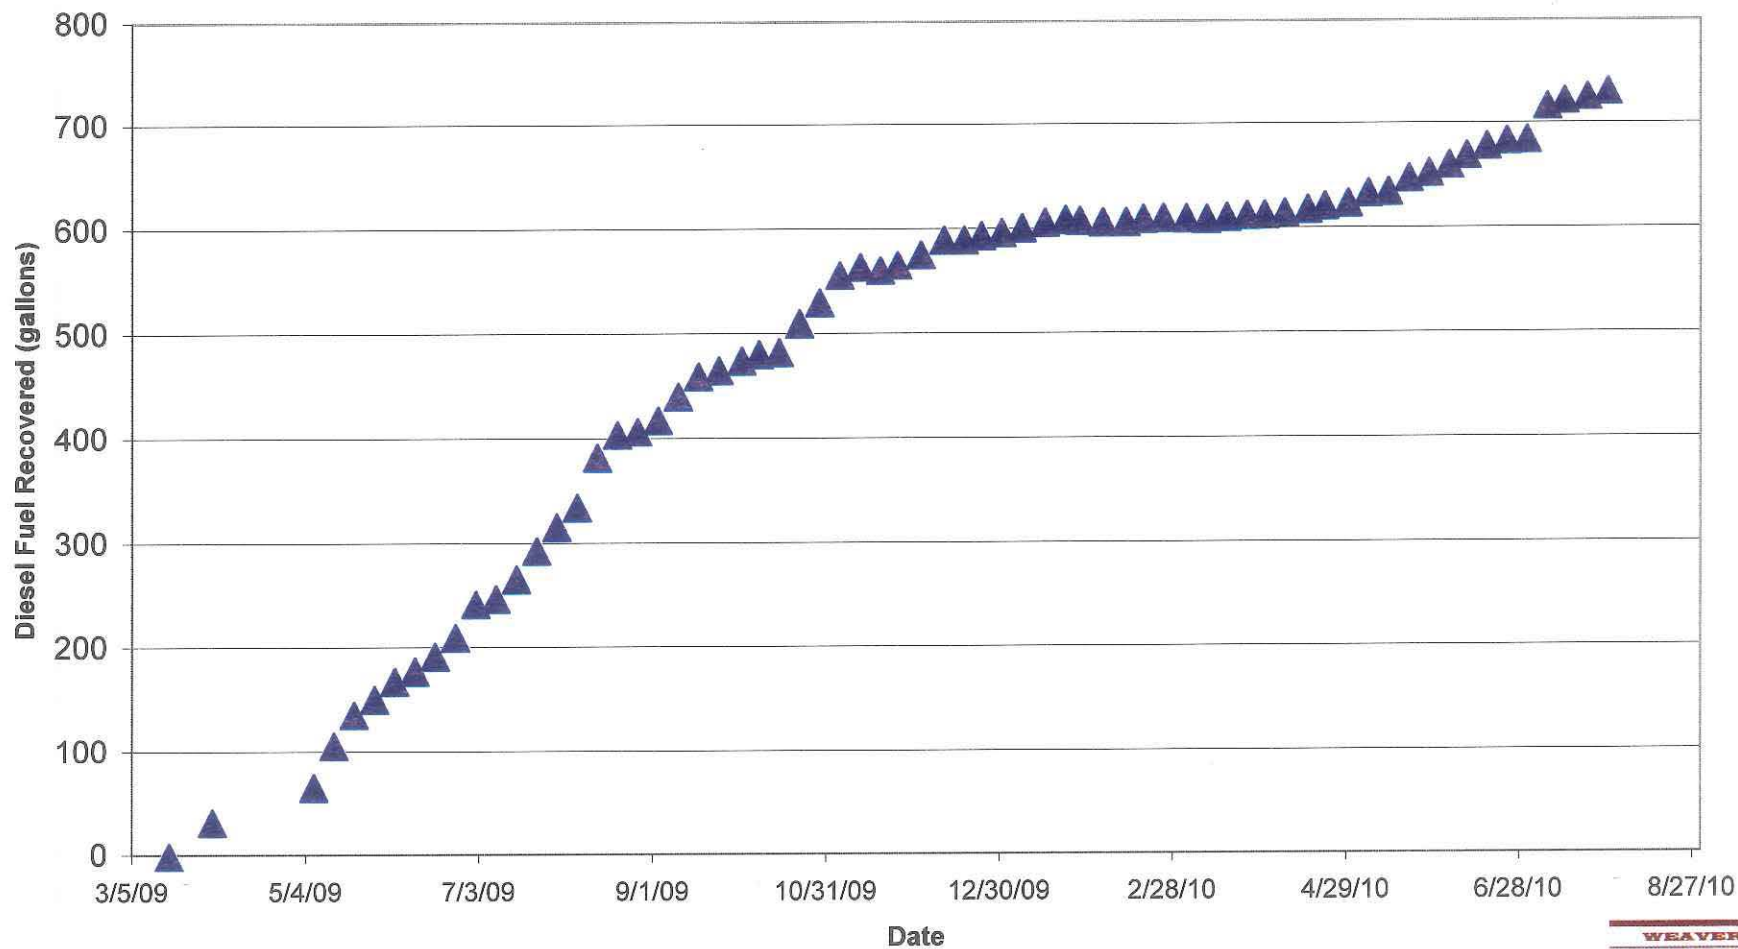
**FIGURE 2**  
**Cumulative Free Product Recovered**  
**Locomotive and Mobile Equipment Shop**

Cumulative diesel fuel recovered is charted as shown on **Figure 2**. The chart of cumulative free product recovered shows an approximately linear trend through October 2009, after which the

accumulation of product began to taper. Beginning in May 2010, the accumulation of free product began to increase again. The calculated rate of diesel fuel recovery (gallons per day) is charted on **Figure 3**. Through October 2009 the rate of recovery frequently exceeded 3.0 gallons per day. Beginning in November 2009 through May 2010, the rate was typically less than 1.0 gallons per day, suggesting a declining trend. During May through July 2010 the rate of recovery increased noticeably.

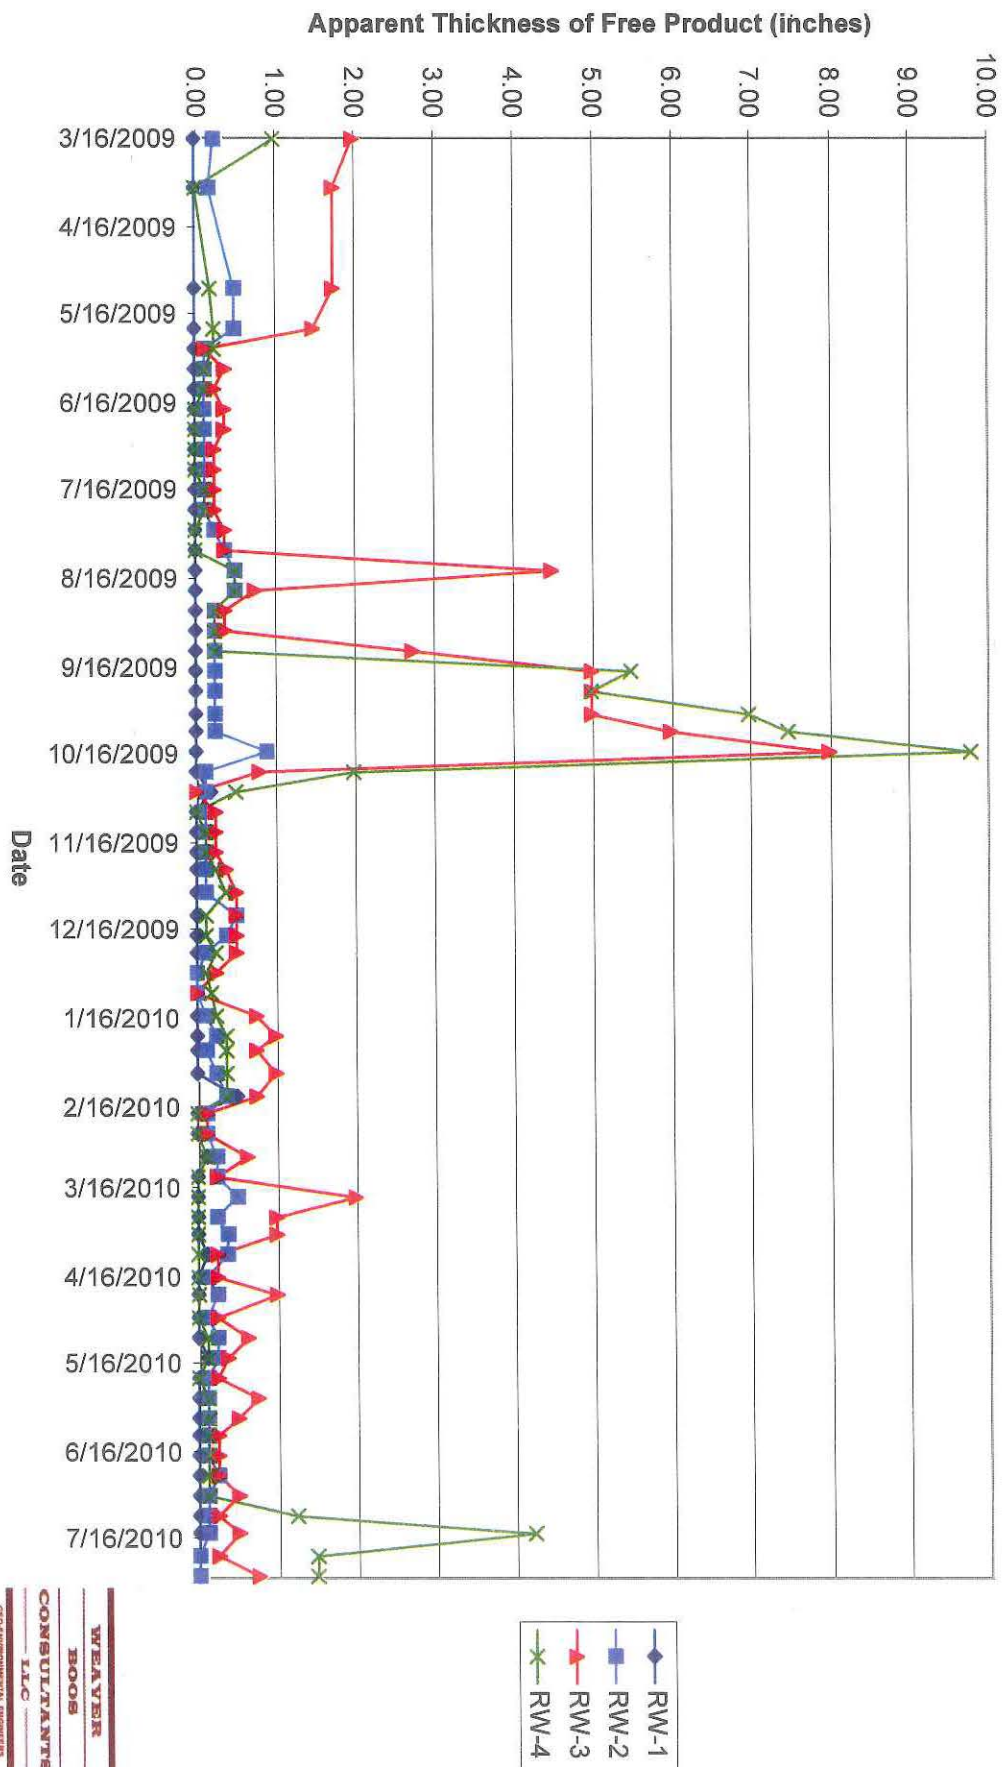
**FIGURE 4**  
**Apparent Thickness of Free Product in Wells**  
**Locomotive and Mobile Equipment Shop**

The apparent thickness of free product measured in recovery wells RW-1, RW-2, RW-3, and RW-4 is summarized in **Table 2**. The thickness is described as “apparent” because it represents what is present in the well at the time of measurement and does not necessarily represent the thickness of mobile free product in the aquifer. The actual thickness in the aquifer formation is usually less than the apparent thickness measured in a well. Additionally, the applied vacuum tends to increase the thickness of free product in a well, while the regular pumping of the recovery wells reduces its thickness. Time trends of apparent free product thickness are charted for the recovery wells as shown in **Figure 3**.
